Datum:
2004-10-19

South Gate of the City wall Kotor, Montenegro

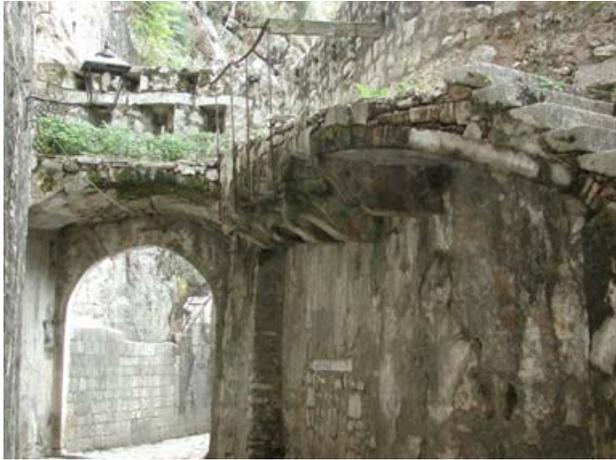
The beautiful walkway adjacent to the parapet is a thin and elastic, almost as hanging free of support, structure. The whole structure has a patina and an ongoing deterioration, which has to, in my opinion, be considered and protected as much as possible. That means that the interventions should be minimized. These values must be evaluated with the security risks, for instance the risk of collapse, if the interventions are not sufficient.

The hanging walkway.

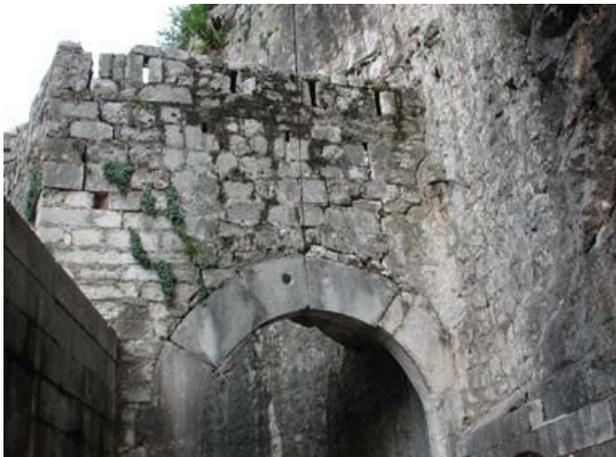
The part of the wall above the porch has diagonal cracks. The stones of the crenulation of the parapet have partly disappeared. One stone block of the vault above the opening has slid down a couple of centimetres.

Defective crenulation and cracks.

The cracks and the slided stone block above the opening indicates that the wall towards the waterside is inclining outwards.

Not to risk further damages and an eventual snap through of the vault the possibility to stabilize the wall must be studied. One proposal is to anchor a steel tie in the wall towards the rock or directly into the rock and connect it with the wall on the water side. This tie must be places close to the porch, and on the inner side. The placement and the design of such a tie must be done with great care, both from esthetical and technical point of view. The tie should perhaps be of stainless steel.

Walls and the vault should be pointed with mortar. The ragged crenellation should be restored in order to protect and stabilize the parapet.

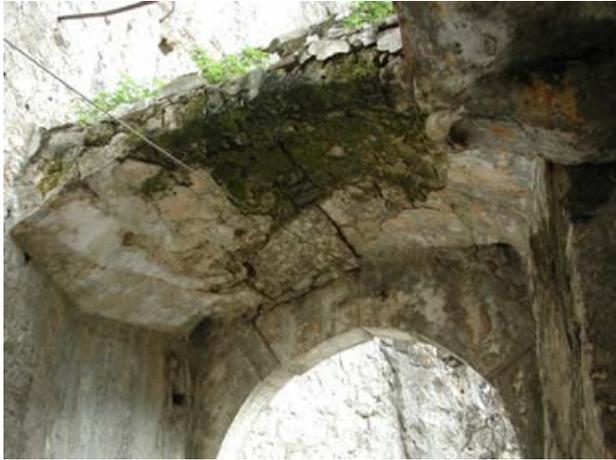
The vault on the inner side of the porch has rather wide cracks in the lower edge. The under-side of the vault is moss- and alga-covered. The stone covering on the upper part of the walkway is damaged and seems to have largely disappeared. At the moment there is some vegetation on the walkway.

The under-side of the porch.

Alga and moss on the under-side of the walkway shows that the vault is very humid and that water protection is missing.

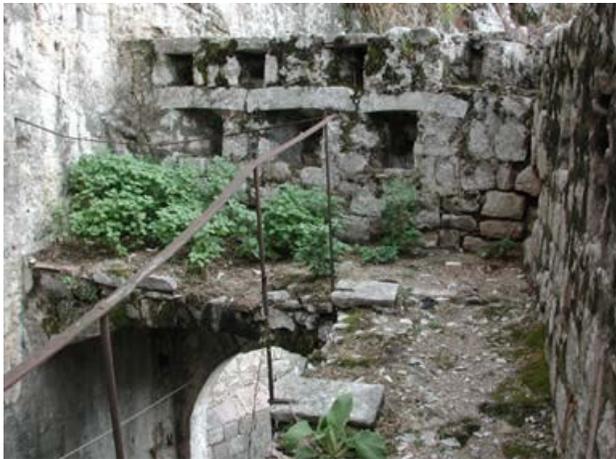
The upper part of the walkway.

The vegetation on the walkway indicates that there for some reason is earth. It could be from an earlier, old mud protection/packing or from degradation products from the walls.

A humidity barrier should be introduced on top of the walkway. It could be made of mud because the risk of freezing is minimal. The vegetation can indicate that there used to be a mud packing, but this should be analysed further. A possible mud packing should be covered with stone coating in mortar to delay vegetation to root. Another solution to obtain some kind of moisture barrier is to lay stone coating in mortar, with or without, for instance, lead sheets.
