THE RESTORATION OF PART OF THE EASTERN WALL AND PAPAZ KULA OF JAJCE FORTIFICATION

REPORT edited by Tina Wik

August 2005 Project by Cultural Heritage without Borders Professor Tina Wik Architect Damir Hadzic Structural Engineer Krister Berggren

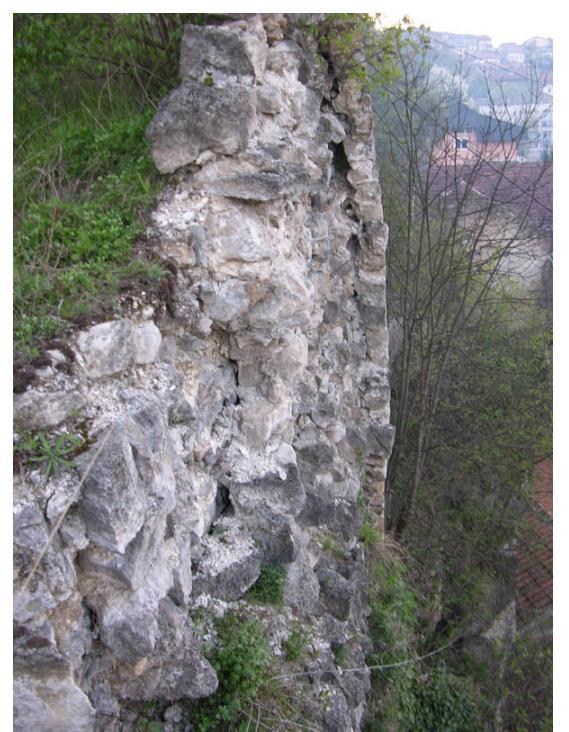
The outer part of the northeast wall of the fort has collapsed. The core is exposed.

This is most likely caused to too much humidity entering the construction and weakening the core and the mortar.

Other parts that are crumbling are on the way to collapse.

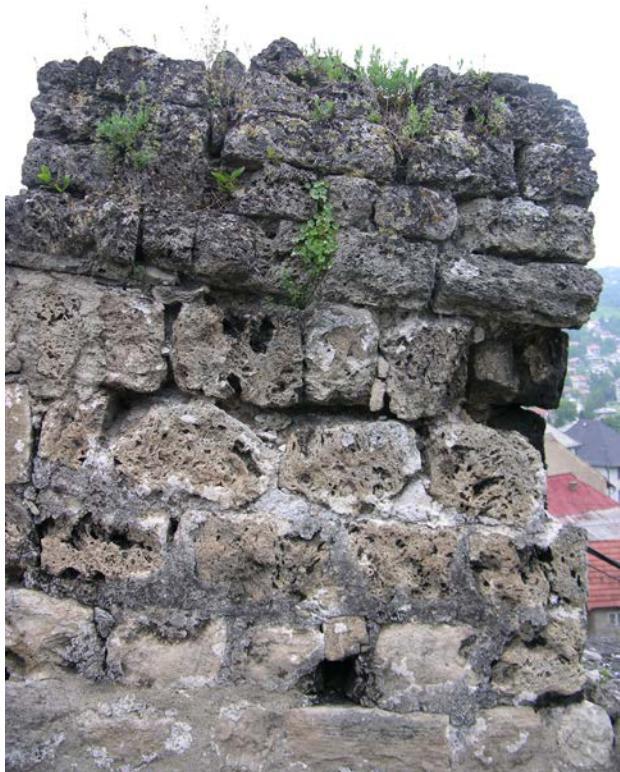
Stones are deteriorating by exfoliation probably caused by frost.

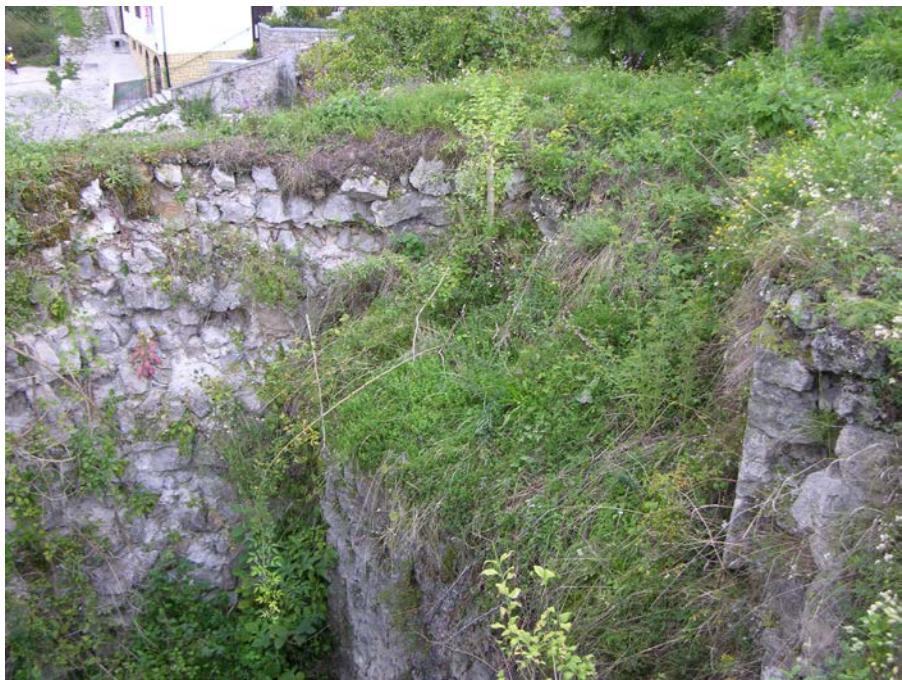
Vegetation growth with strong roots damages the walls while vegetation growth with soft roots could protect it.

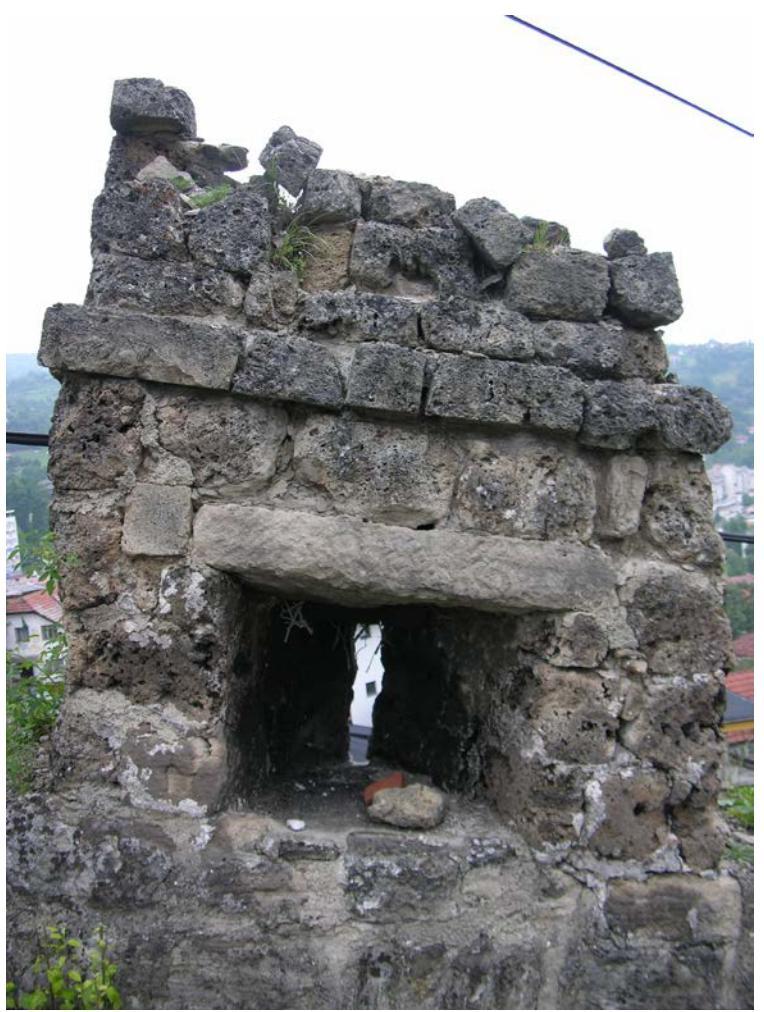
Parapets-breastwork damage caused by deteriorated stone, leaking mortar or cracked constructive stones or missing clams.

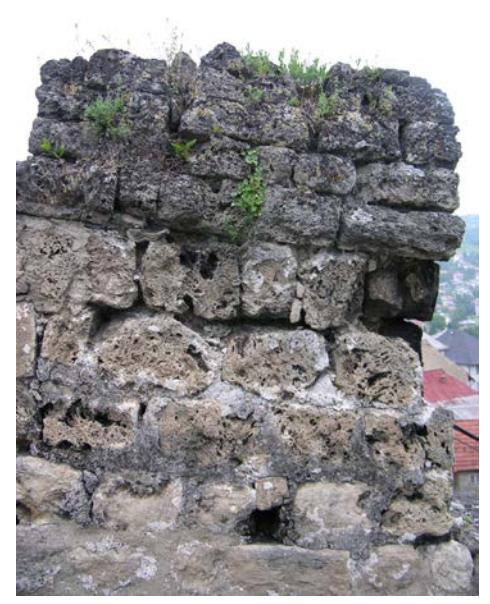
Vegetation must be removed and missing stones

installed. Pointing must be carried out in the cavities between the stones. Three crenellations were missing and brought back on place!
