Datum:
2004-10-19

South Gate of the City wall Kotor, Montenegro

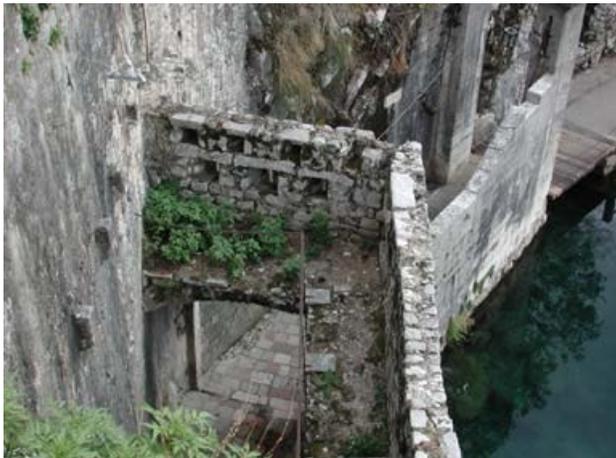
The porch and the walkway from the inside of the fort.

The beautiful walkway adjacent to the parapet is a thin and elastic, almost as hanging free of support, structure. The whole structure has a patina and an ongoing deterioration, which has to, in my opinion, be considered and protected as much as possible. That means that the interventions should be minimized. These values must be evaluated with the security risks, for instance the risk of collapse, if the interventions are not sufficient.
