Final Report

Passive Cross Laminated Timber Buildings

Cerbof-project no. 76

April 2013

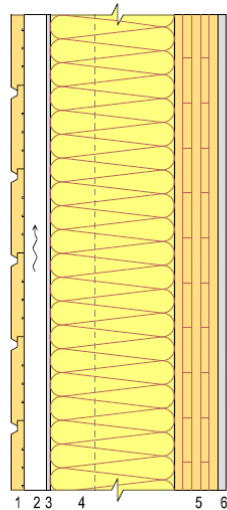
1. Façade
2. Air cavity
3. Wind barrier
4. Insulation
5. CLT panel
6. Plasterboard

Figure 8. Stora Enso's construction of the external wall. There is no internal plasterboard in the test building.

Figure 8 illustrates how the wall is built up in section. The walls are approx 50 cm thick and as well as 97 mm CLT panels are comprised of 365 mm insulation boards and have an average U value of 0.093 [W/m².K].

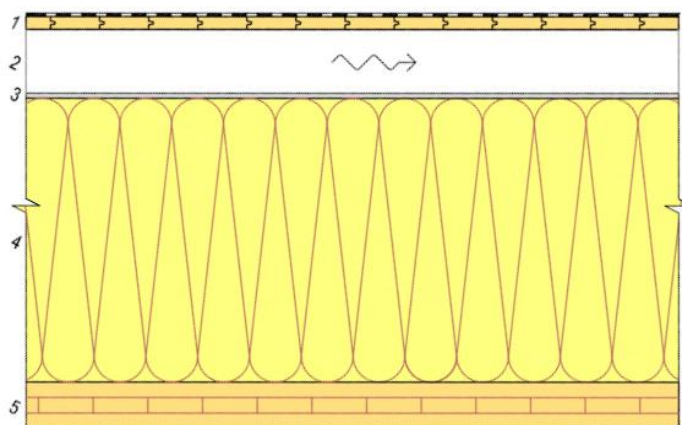
1. Roofing, tongued and grooved boarding and roofing felt
2. Air cavity, varying width
3. Wind barrier
4. Insulation with lightweight joists
5. CLT panel

Figur 9: Stora Enso's roof construction

The roof consists of, from the inside, a 138 mm CLT panel, 500 mm insulation in boards, wind barrier and roof covering and has an average U value of 0.075 [W/m².K]. The roof construction is illustrated in figure 9.

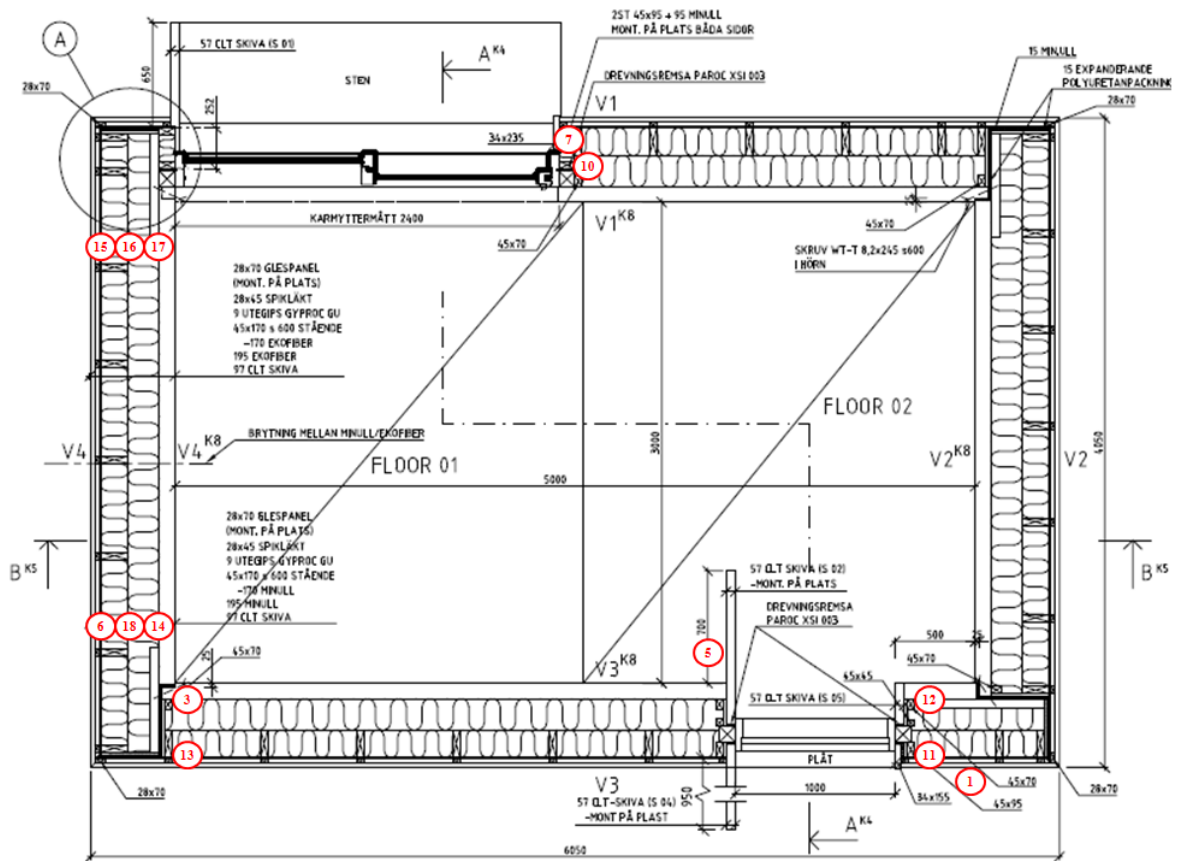
Figure 11. Plan and section of the test building. In the upper drawing, east is on the right and in the lower drawing, south is on the right.

The test building has been followed up by continual measurement of the energy consumption, temperature, humidity and air tightness. The system for temperature and humidity measurements consists of 18 sensors (BaWit) which together measure the two measurement parameters and log the data. The location is shown in figure 11. The location of the sensors is mainly based on two main parameters, partly to study the natural moisture diffusion through a homogeneous section of the wall without plastic sheeting, and partly to study the moisture diffusion and temperature gradient in the different junctions in the building, such as joints in the panels or the window fixings where there is a risk of air leaks. In the east wall, on the left in the figure, half of the wall is insulated with mineral wool (sensors 15-17) and the other half is insulated with wood fibre insulation (6, 18, 14) to show possible differences, not least of the moisture content in the wall, between the two methods of insulation. The sensors are placed in the upper part of the wall, in the junction between the CLT panels and the insulation, in the middle of the insulation layer and also in the junction between the insulation and the plasterboard.

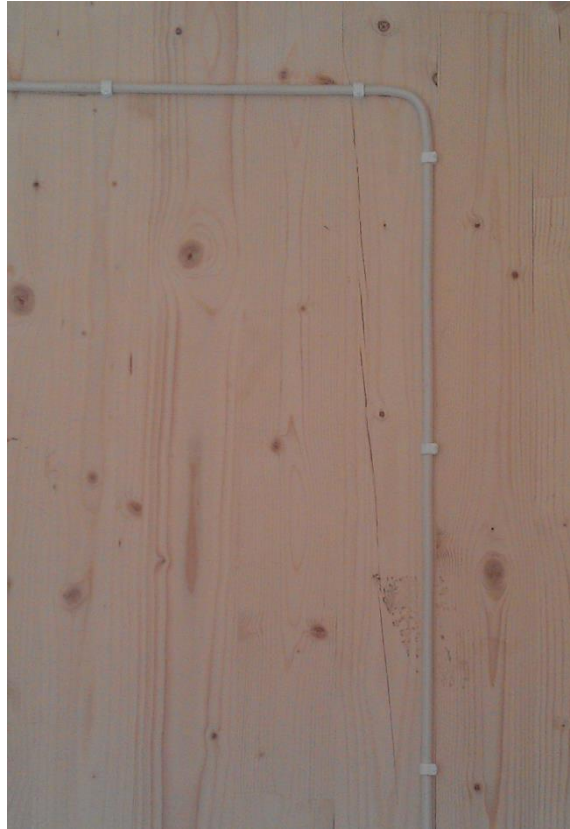
Figure 12. The picture shows cracking in a CLT panel approx. five months after the assembly of the building. However, thermography in connection with pressure testing shows no sign of this cracking causing any extra air leakage, partly because the CLT panel is built up of several layers.

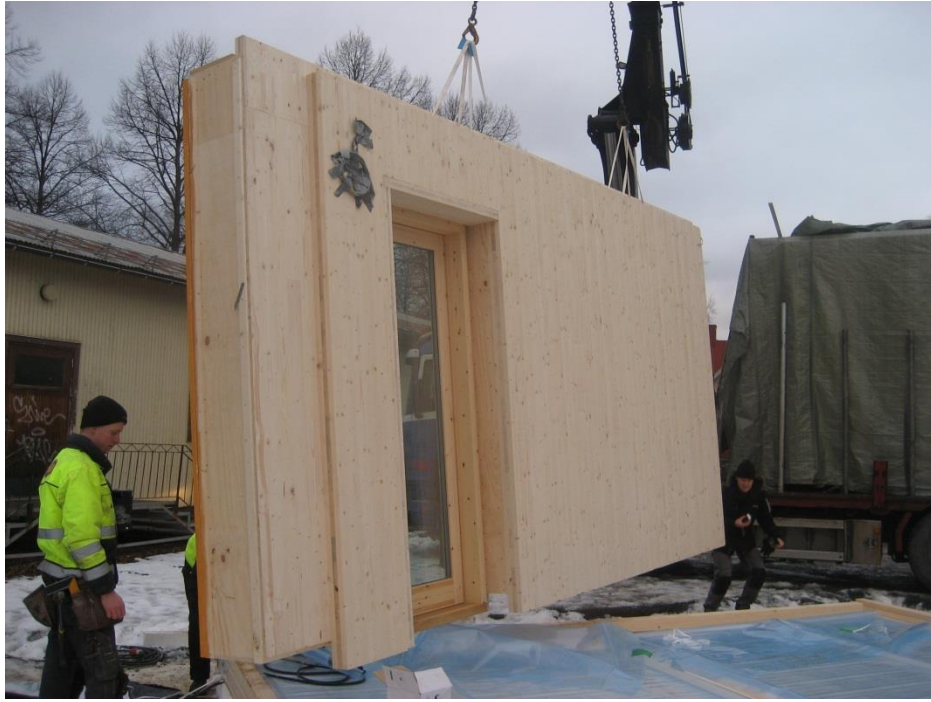
Figure 14. Assembly of the north wall. The position of the lifting loops means that the wall leans somewhat which makes placing it on the floor element more difficult.

- The position of the lifting loops caused problems in assembling the wall elements as they hung asymmetrically which caused an angle when they were sunk down towards the floor. This meant that it was difficult to lower the panels into the rebate which had been prepared in the foundation panels, see figures 13 and 14.

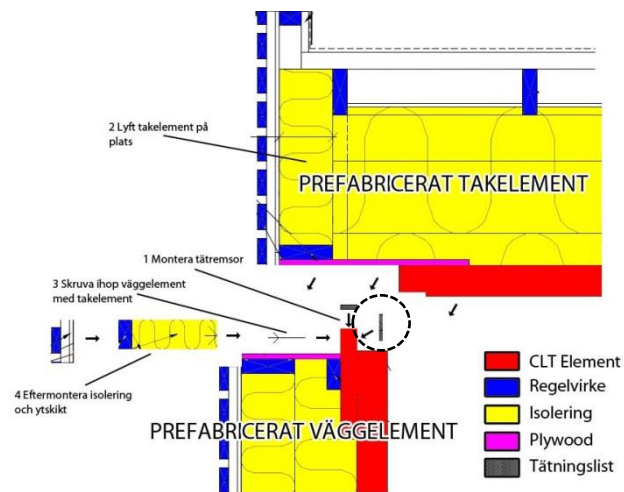
Figure 15: Detail of joint between roof and wall elements. The sealing strip which tended to be in the way and to be damaged when the roof was laid on top is shown by a circle.

- The position of the sealing strips should be studied in more detail. This is particularly important in the joint between the wall and roof where the roof had a tendency to fasten in one of the sealing strips and pull it down. See figure 15 below:

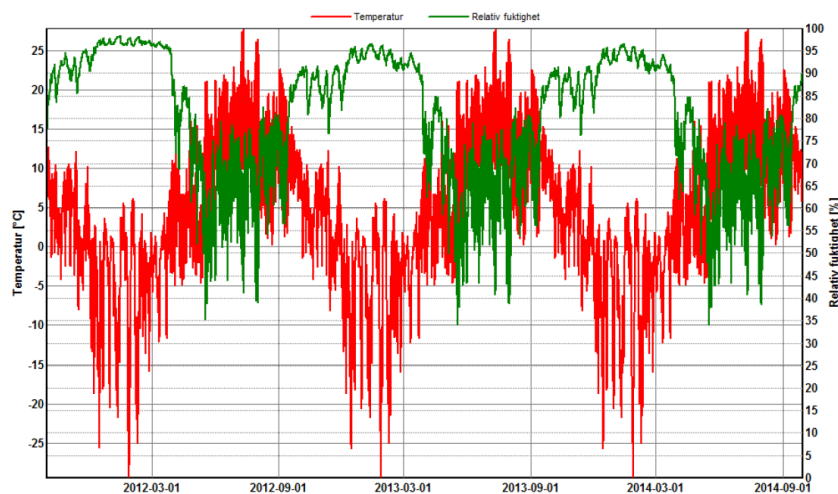
Figure 19: Relative humidity and temperature in the junction between the thermal insulation and exterior plasterboard, wood fibre insulation in the wall, no paint on the outside of the exterior plasterboard.

In the second simulation, which was used as the basis for the decision on the choice of paint for the building, the conditions were changed by a change in the water vapour transmission rate of the paint. Taking into account that the building was constructed without plastic sheeting it is especially important that the coat of paint on the exterior plasterboard has very high water vapour transmission which contributes to the inside of the building continuing to be more airtight than the outside. In figures 19 and 20, the simulations show the effects of humidity and temperature through the wall section over time and with paint on the exterior plasterboard. The result of these simulations shows that the movement of water vapour in the section studied is radically reduced when paint with a water vapour resistance of (Z) 100 000 s/m is applied to the exterior plasterboard. The average annual relative humidity is also markedly raised compared with when the surface is untreated. This emphasizes the importance of using a highly permeable wall paint which was one reason for the choice of paint for the walls of the building. In this case the choice was a silicate paint manufactured by Keim. It is manufactured without additives of plastic components and thus has a low water vapour transmission resistance. The chosen paint was KEIM Granital® and is a water repellent, ready to use, silicate based paint with a water vapour resistance of (Z) of 400 s/m according to data from Keim's technical information sheet.

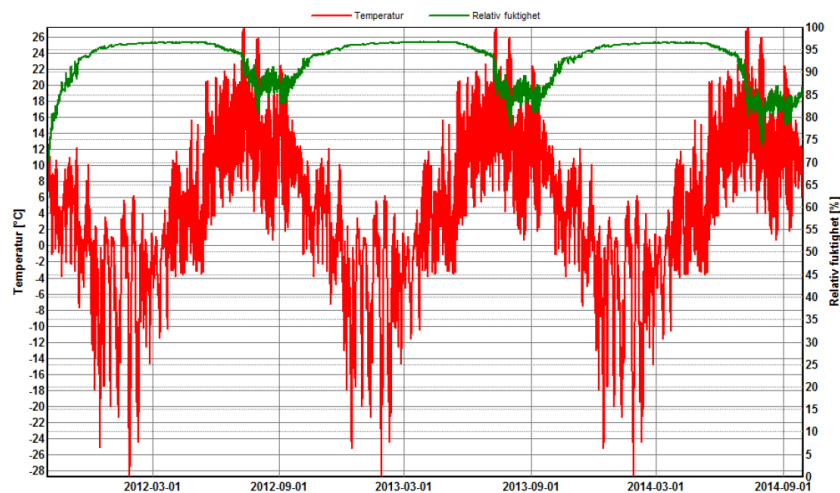
Figure 20: Relative humidity and temperature in the junction between the thermal insulation and the exterior plasterboard, wood fibre insulation in the wall, paint with $Z=100\ 000\ \text{s/m}$.

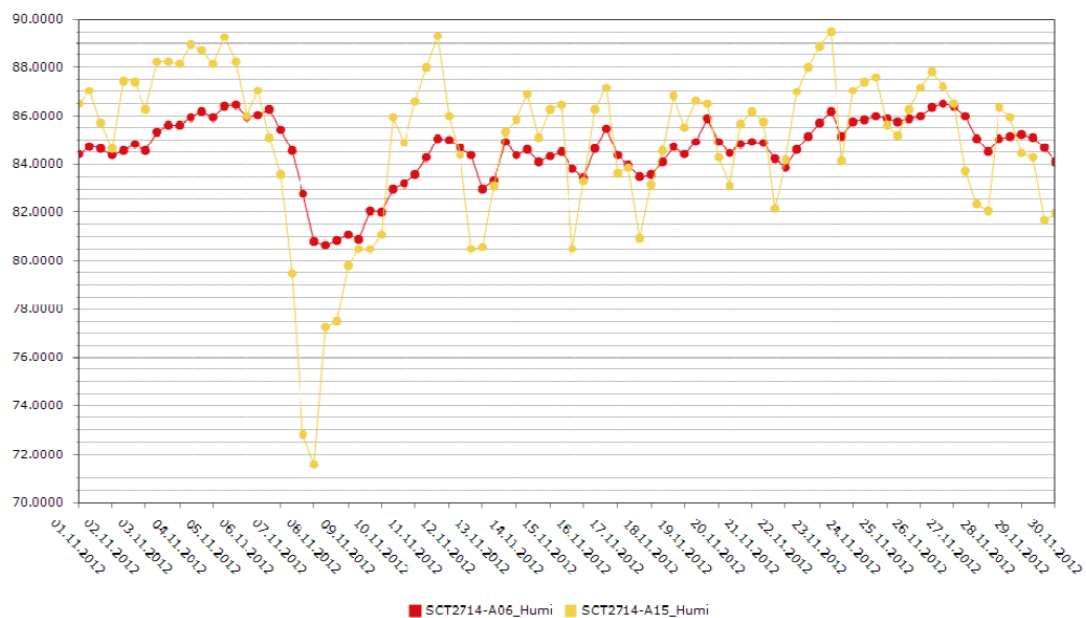
Figure 21: Relative humidity in the insulation in the eastern external wall during November 2012 for wood fibre insulation (red curve) and mineral wool insulation (yellow curve).

The figure below, Figure 21, shows the measured values during November 2012 from sensors 6 and 15 which are placed in the insulation layer inside the exterior plasterboard on the east side of the building. The red curve shows the relative humidity 20 mm in from the edge of the wood fibre insulation while the yellow curve shows the humidity 20 mm in from the edge of the mineral wool insulation. This layer is strongly affected by the outdoor climate so that the relative humidity can be rather high at times, and can also vary depending on the outdoor temperature; this can also be seen from the measurements.

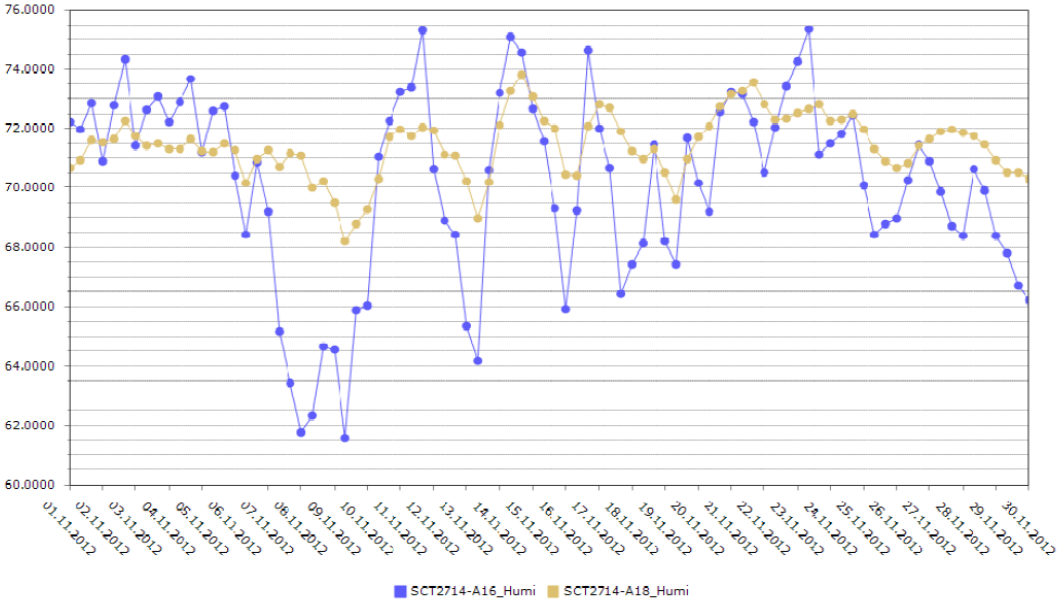
Figure 22. Relative humidity in the insulation in the eastern external wall during November 2012 for wood fibre insulation (yellow curve) and mineral wool insulation (blue curve).

Figure 22 shows the relative humidity in the east wall 120 mm in from the outside of the insulation for the month of November 2012. As the wall was composed partly of wood fibre insulation (yellow curve) and mineral wool insulation (blue curve) the humidity is shown in both these insulation materials. As the wood fibre insulation stores the moisture this leads to a more even and somewhat lower curve for the relative humidity in the insulation. The values which are registered are on a par with what is expected from the simulations for an external wall with high water vapour transmission.

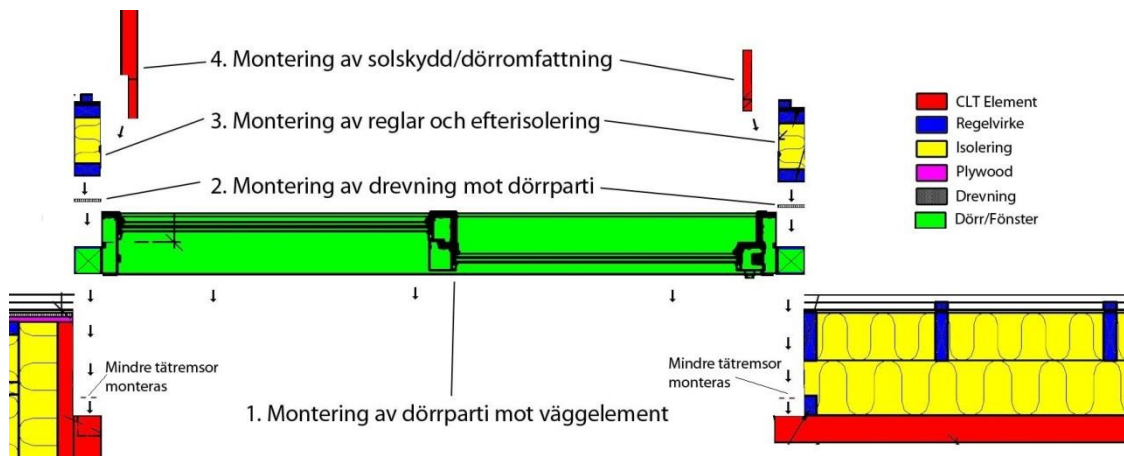
Figure 26: The order of assembly of the sliding door screen in the wall element (Fyhr, 2012)

Regarding the entrance door, which contributed 34 % of the air leakage, it was designed to be further out in the wall compared with the sliding door screen and its fixings, which were shown to be very airtight in the measurements, see figures 26 and 27.

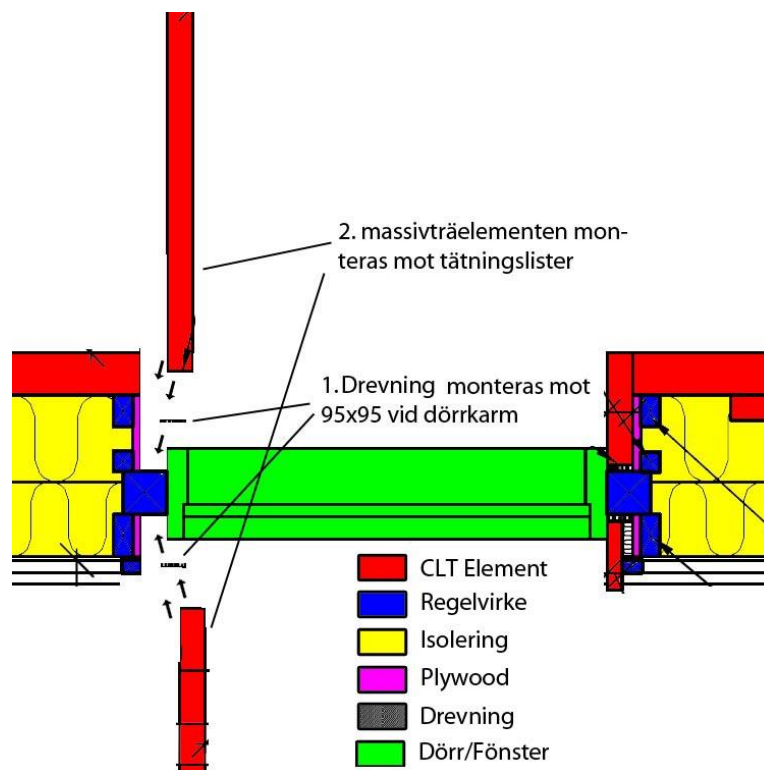
Figure 27: The assembly of the entrance door in the wall element (Fyhr, 2012)

The position of the entrance door towards the outside of the wall was one reason why door linings of CLT had to be added on site, when one of the internal door linings was extended to create a screen in the room. In comparison with the sliding door, the position of the entrance door contributed to several potential leakage points through the junctions between the CLT panel, the door linings and the entrance door. As the CLT screen was assembled on site it was more difficult to move it against the studs in the doorframe and create an airtight joint compared with the fixing of the sliding door.

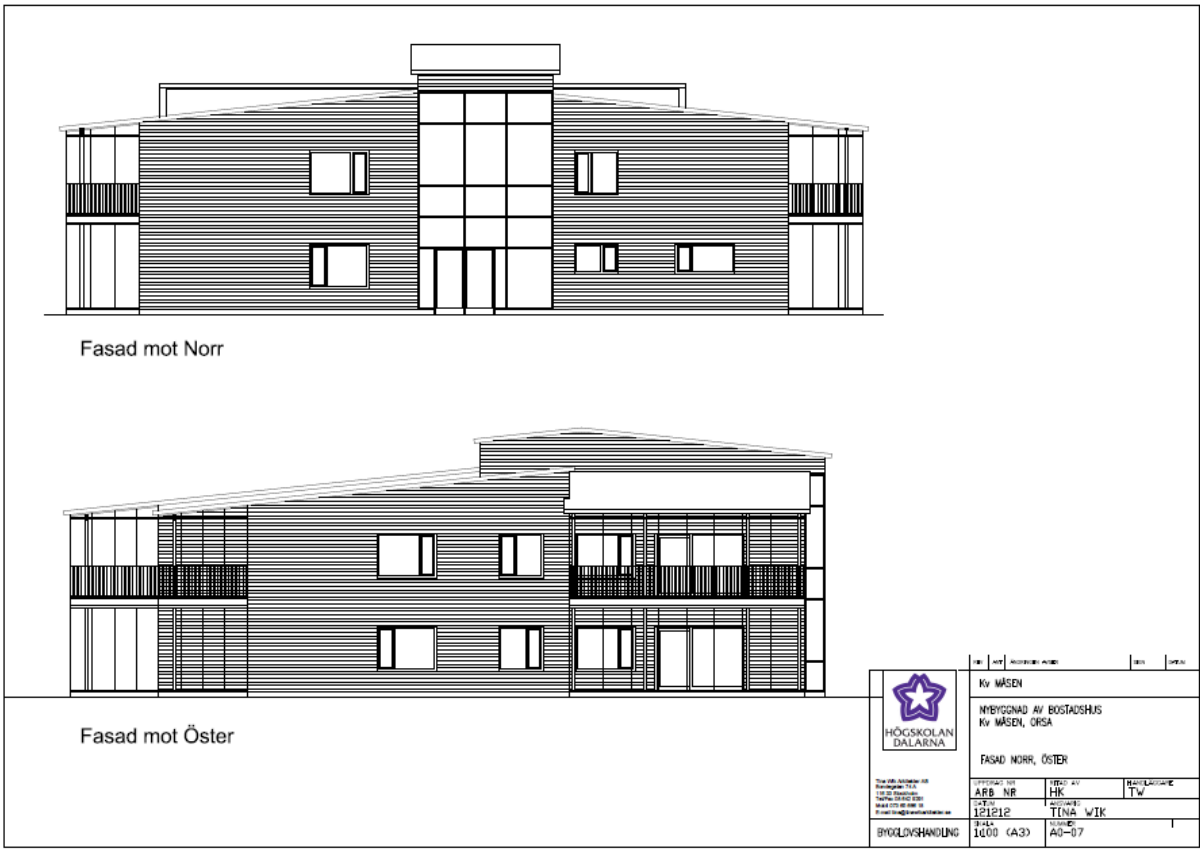
Fasad mot Norr

Fasad mot Öster
